Özge Yılmaz, Ph.D.

3rd Nov. 2020

# INNOQUA

#### **INNOQUA System**

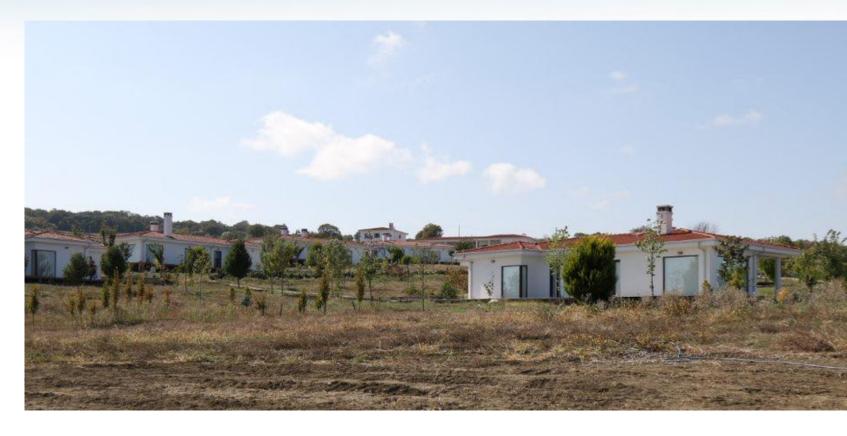
The INNOQUA system treats the wastewater from a residential complex with 8 detached

houses and a building for social activities. The complex has the capacity to host approximately 55 people.

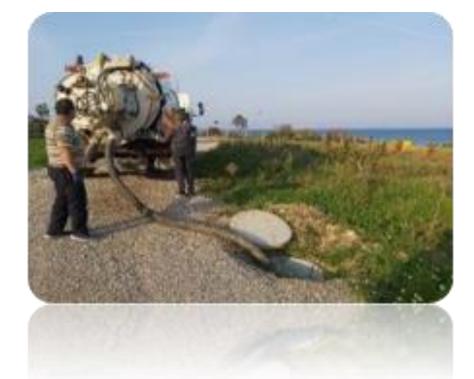
#### Lumbrifilter

Lumbrifilter operational since 09.07.2019

Generally lumbrifilter was observed to be highly resilient to variable conditions (particularly during COVID-19 lockdown).

Regarding the analyses results, the performance of INNOQUA system in Sinop demosite seems sufficient (particularly for Lumbrifilter).

- Lumbrifilter presented significant average removals of  $NH_4$ -N (63.7%), turbidity (49.7%), TSS (39.5%), BOD<sub>5</sub> (37.6%) and COD (33.7%).
- Although, Lumbrifilter was not specifically designed to eliminate **TP removal** efficiencies for this parameter averaged 48.4%.
- Daphniafilter contributed to removal of all parameters including turbidity.
- An average of 1.6 log removal was achieved in the UV unit.

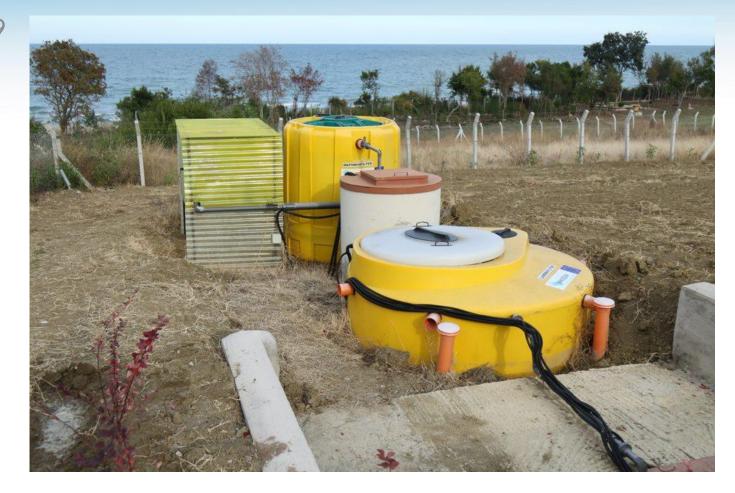
#### Daphniafilter

Daphniafilter operational since 15.11.2019

Removal rates were variable during the demonstration phase.

Less than expected removal rates due to underloading, which caused problems in sustaining sufficient populations of daphnia.
